NASA TECHNICAL NOTE

NASA TN D-4879

RADIOFREQUENCY TRANSMISSION CHARACTERISTICS OF SEVERAL ABLATION MATERIALS

*by Melvin C. Gilreath, William F. Croswell,
and Stark L. Castellow, Jr.*

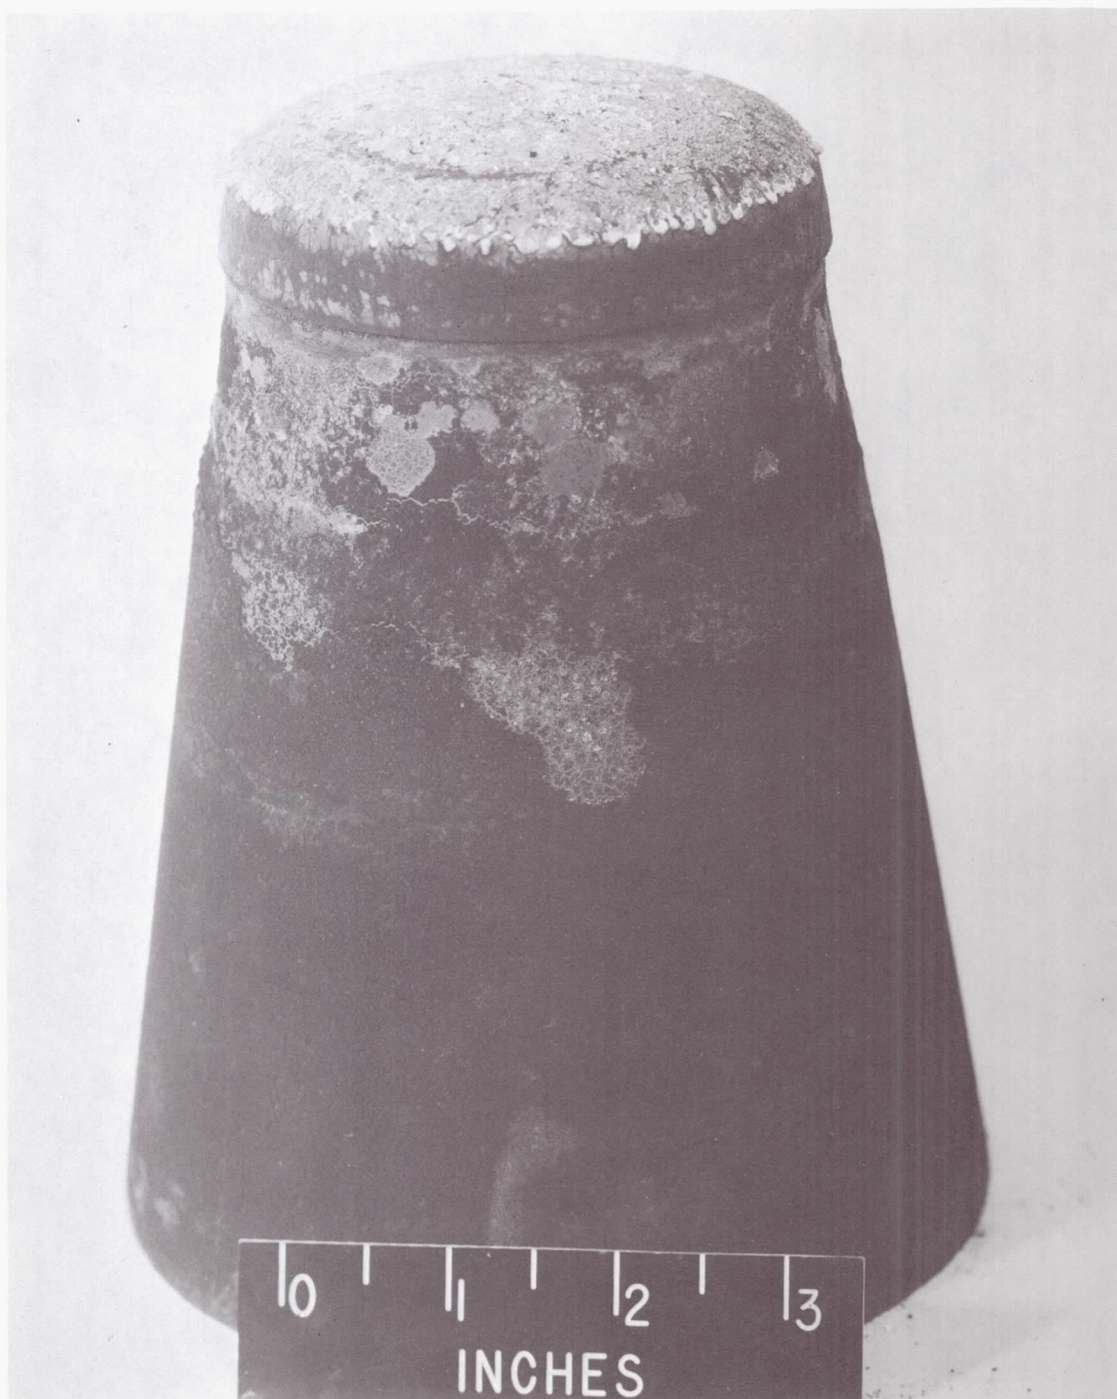
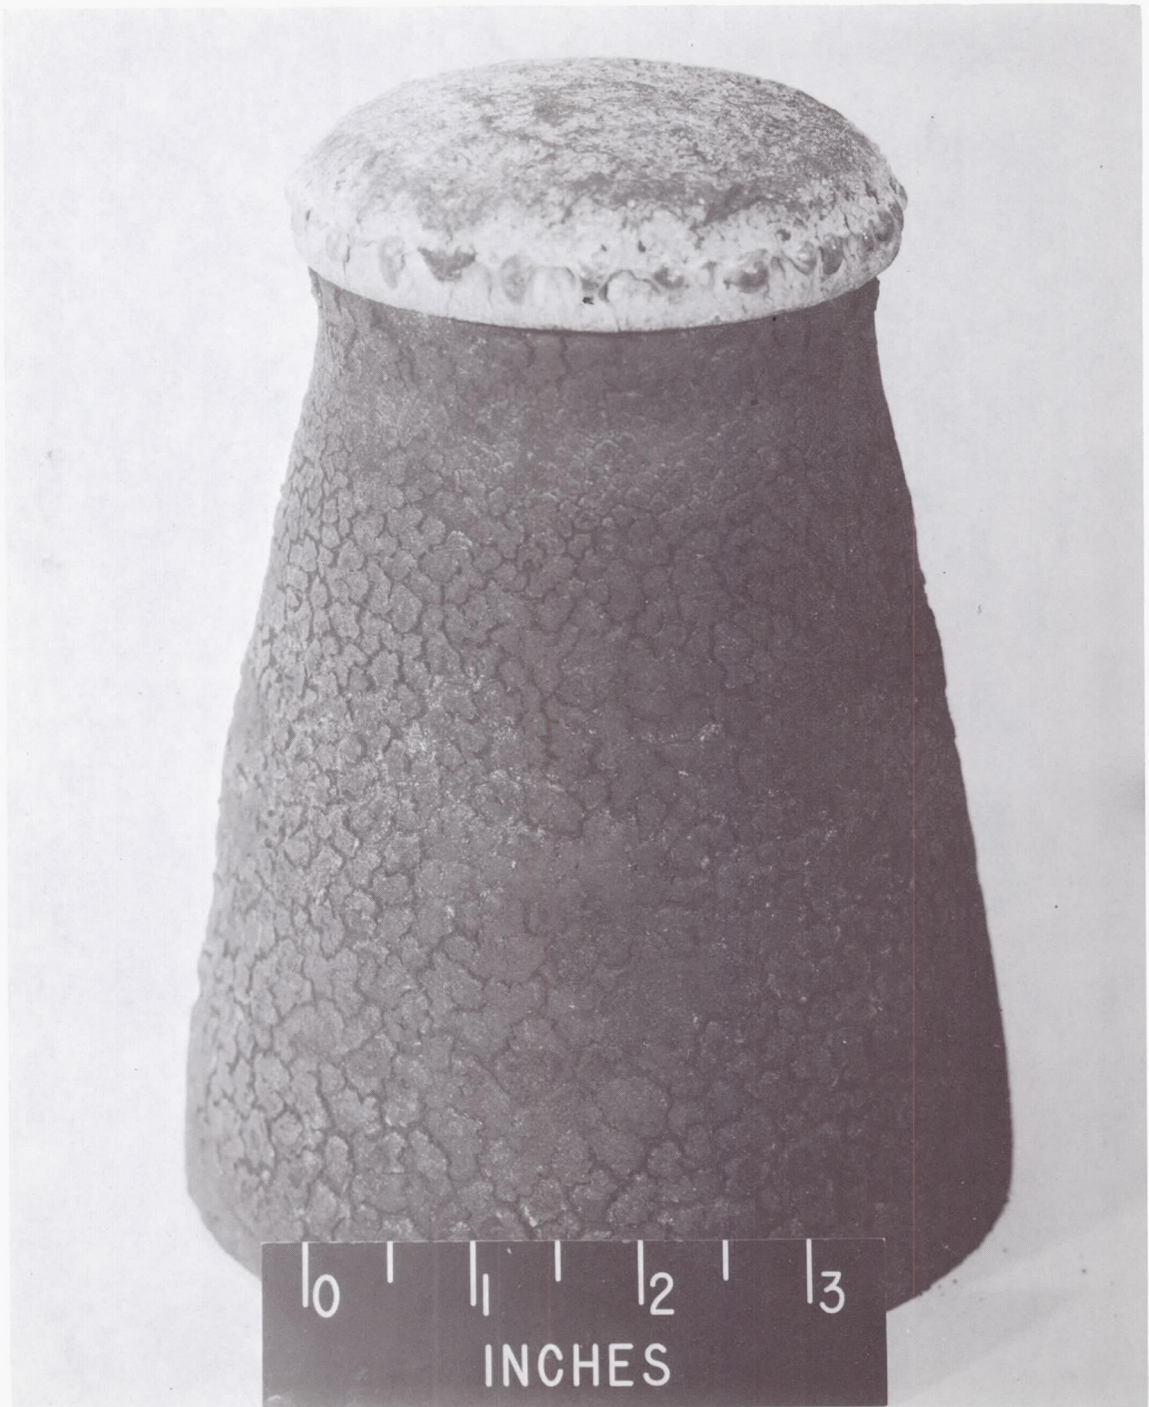
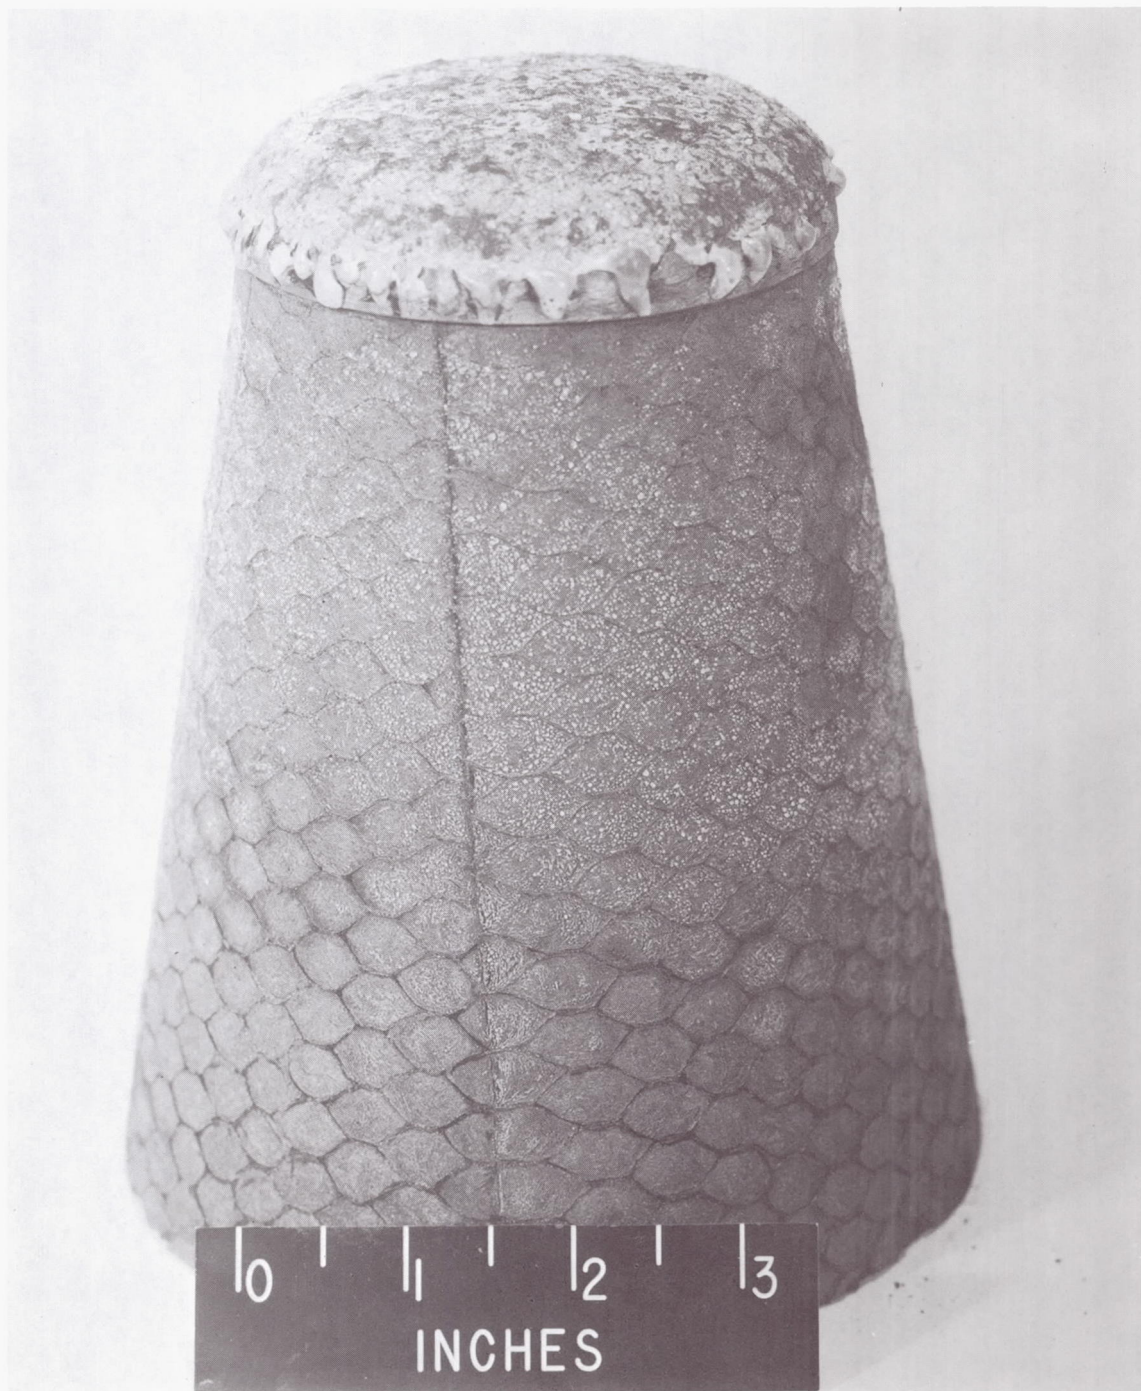
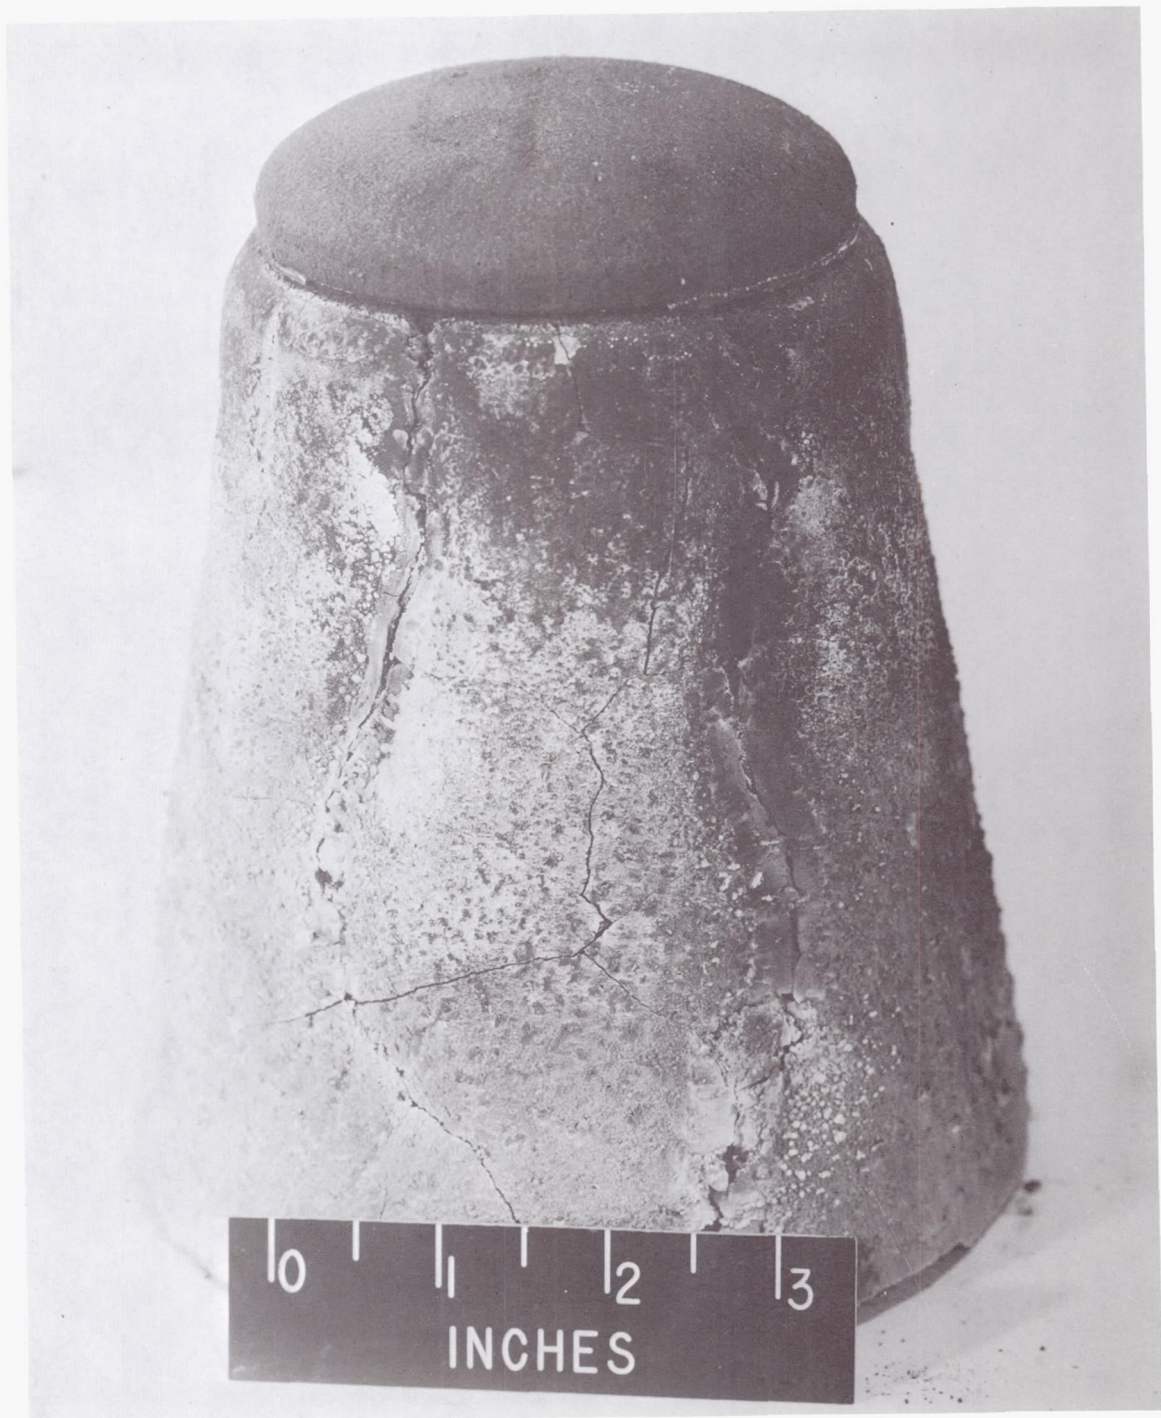
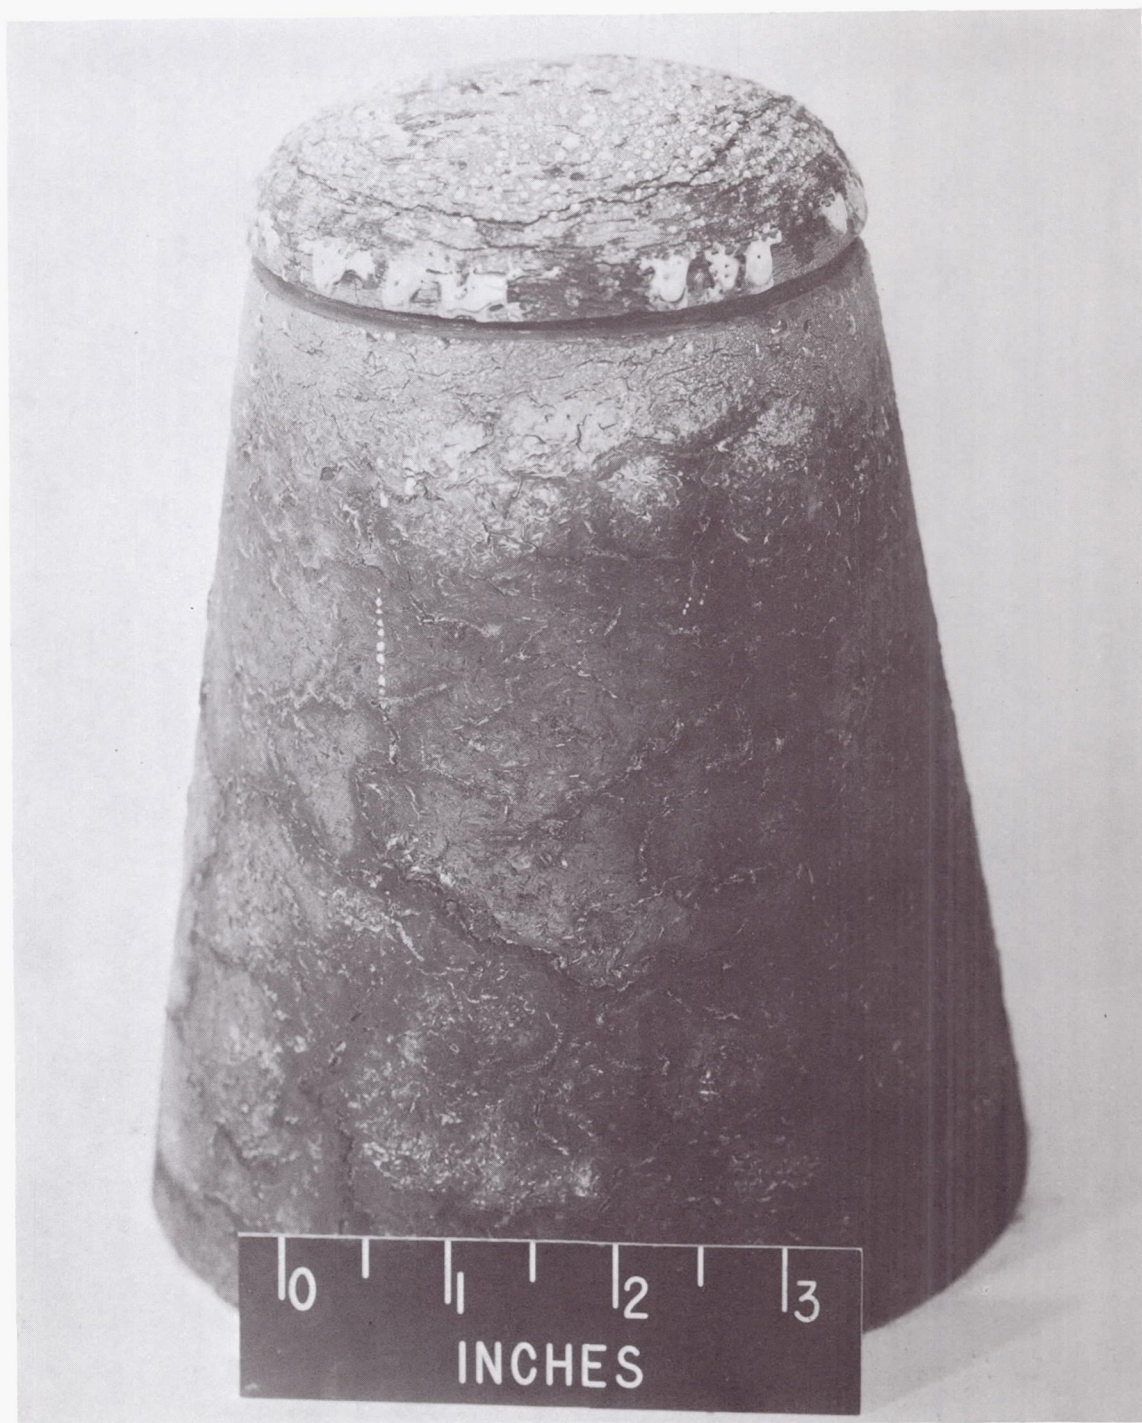
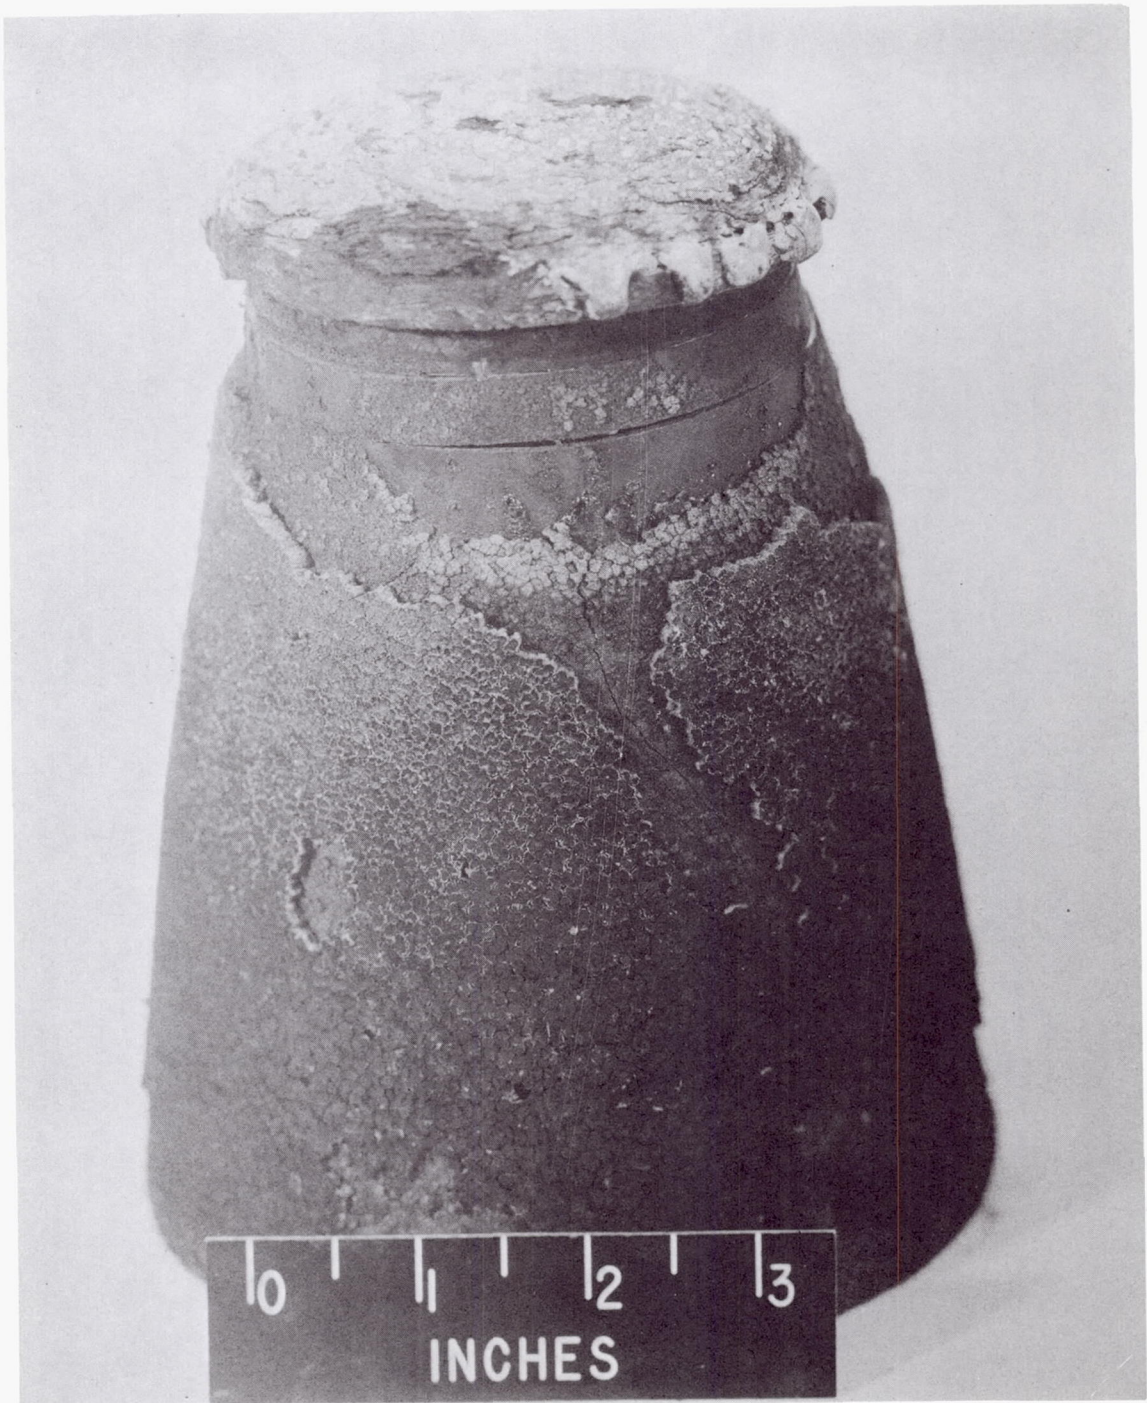
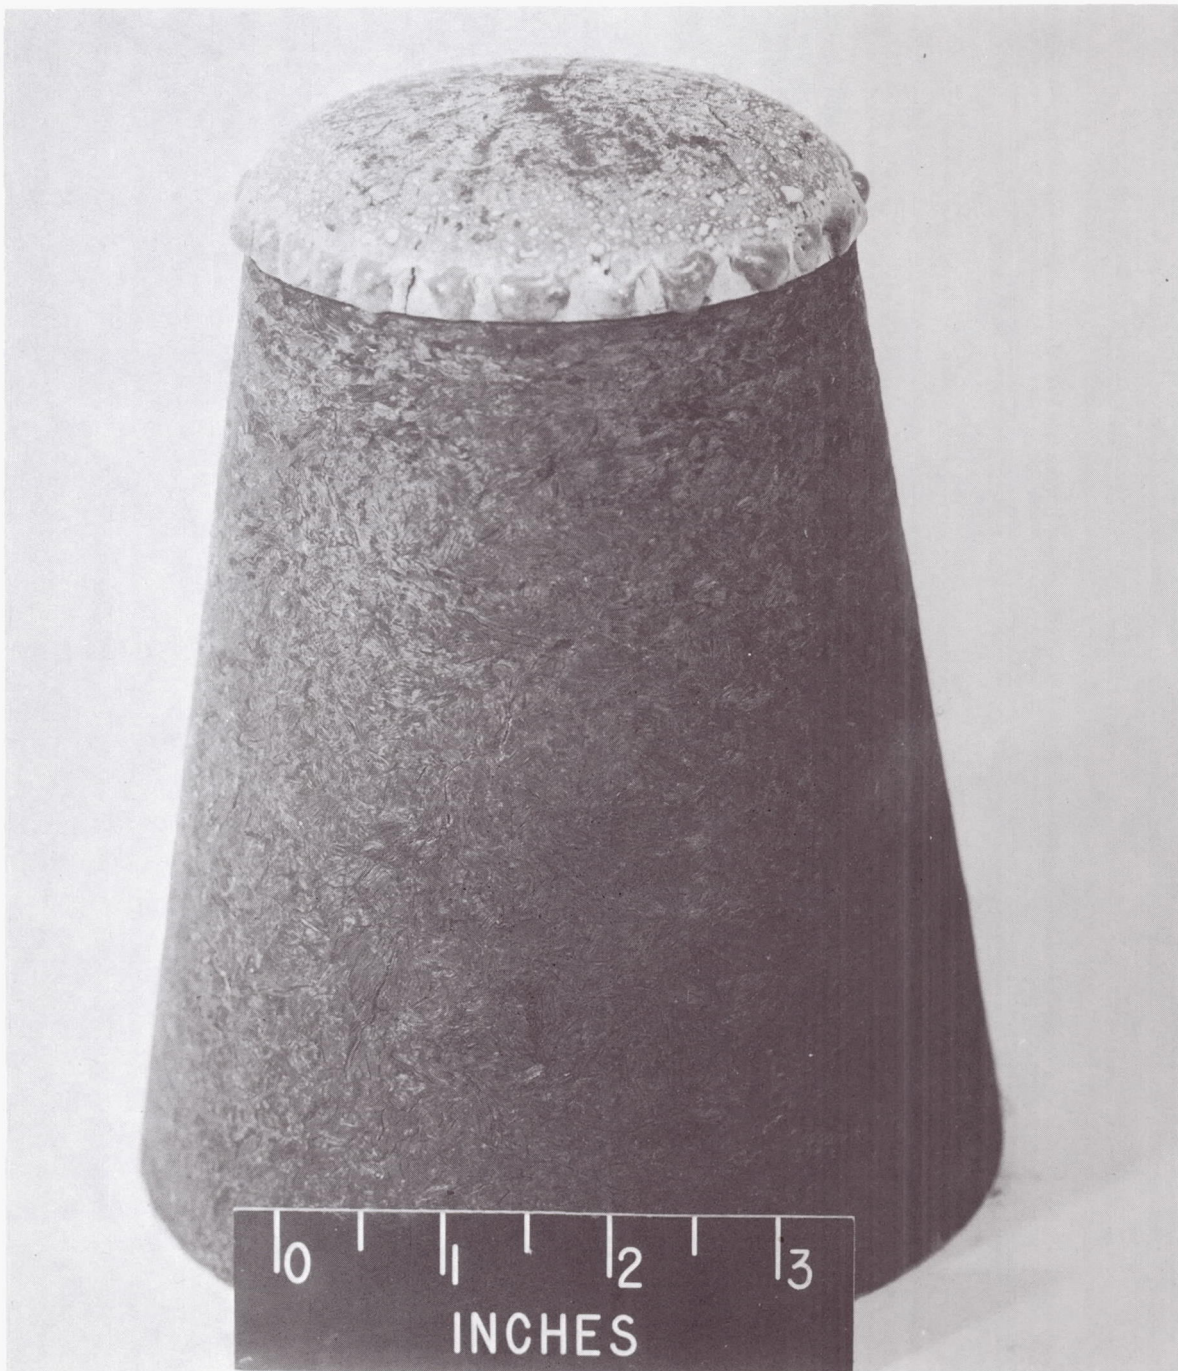
Figure 10.- Models after testing.

(a) Avcoat II.

(b) Cork.

(c) Avcoat 5026-39.

(d) NASA E4A1.

(e) Narmco 4032-C.

(f) Phenolic nylon.

(g) Narmco 4028.

Photographs of the models after they were subjected to the thermal test are shown in figure 10. In this section the irregularities that could cause errors in measurement of the antenna characteristics of some models are described.

Figure 10(a) shows the Avcoat II model, which is partially covered with a residue that resembles soot in both color and texture. The cork-covered model is shown in figure 10(b). Almost all the test material was consumed during the thermal test, and

that which remained had the appearance of a wood char. The Avcoat 5026-39 model is shown in figure 10(c). A deposit of glass was left on the upper portion of the model, apparently from the erosion of the phenolic-asbestos nose cap. The test material appeared to be charred to the bond line. Figure 10(d) shows the E4A1 test model, on which a low-density phenolic-nylon nose cap was used. Immediately after the thermal test began, large cracks developed in the test material; however, as the test continued the cracks appeared to close up somewhat until they reached the condition shown in the photograph at the end of the test. Some of these cracks occurred over the test antennas. In addition, this model had to be handled with extreme care to permit measurement of the antenna characteristics after the thermal test because the material appeared to be separating from the substructure at the bond line and was very fragile. Figure 10(e) shows the Narmco 4032C material which developed many small surface cracks during the thermal test. The phenolic-nylon model (fig. 10(f)) shows the type of carbonaceous char layer formed during the ablation of this type of material. The material appeared to be charred completely to the bond line and the nose cap was fused to the substructure and had to be sawed off to allow removal of the test antennas. A considerable amount of material had fallen off the model, making measurement of the antenna characteristics difficult. Figure 10(g) shows the Narmco 4028 material, which, like the Narmco 4032C material, developed many small surface cracks during the thermal test.
